Worldwide repairs carried out with PolymerMetal®

REP-# 137

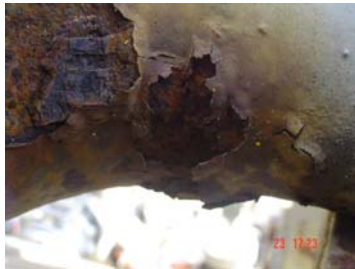
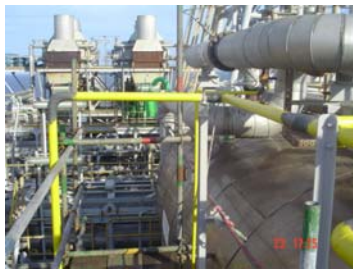
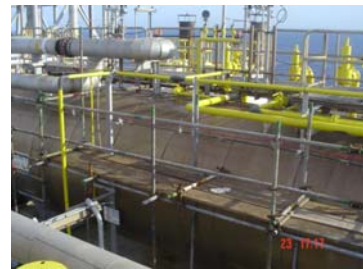
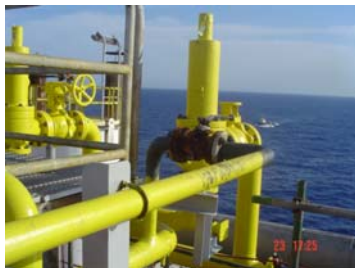
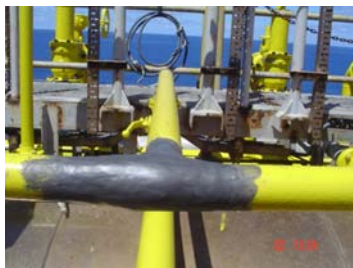
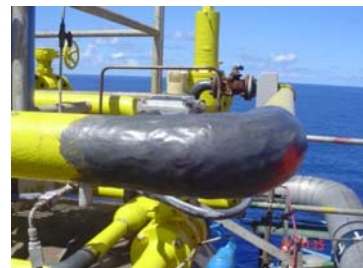
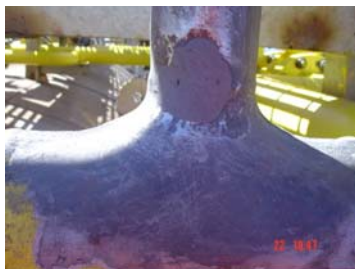
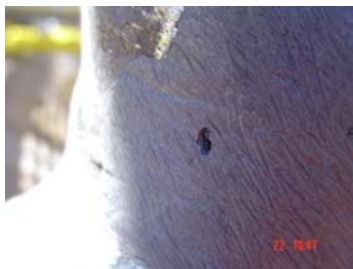
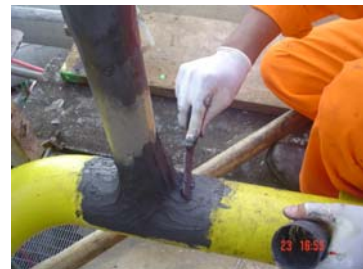
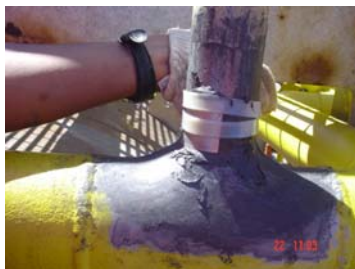
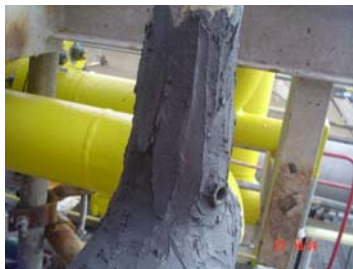
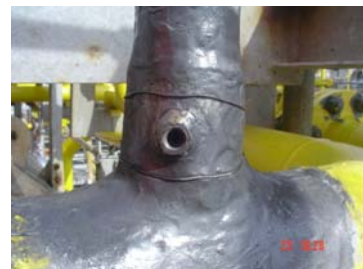
Due to steady climate influence (salty air and rainfall) several strong corroded areas and a leakage of a natural gas carrying pipe system on an oil platform have been repaired with MM-metal oL-steelceramic. To avoid any extra costs the repair was carried out without switching off the system and so the repair has been done at a pressure of 10 bar. Gas streamed out of a leakage of a 10 inch, therefore a provisional valve was built, through which the gas was able to stream out until the final closure of the leakage. A construction consisting of a plate and a nut was made, which was then fixed on the leaky place of the pipe by using MM-metal oL-steelceramic. After the PolymerMetal was cured this valve was closed by using a screw. Finally a coating of MM-metal oL-steelceramic was applied over the complete provisional construction for safety reasons.
