Worldwide repairs carried out with PolymerMetal®

REP-# 094

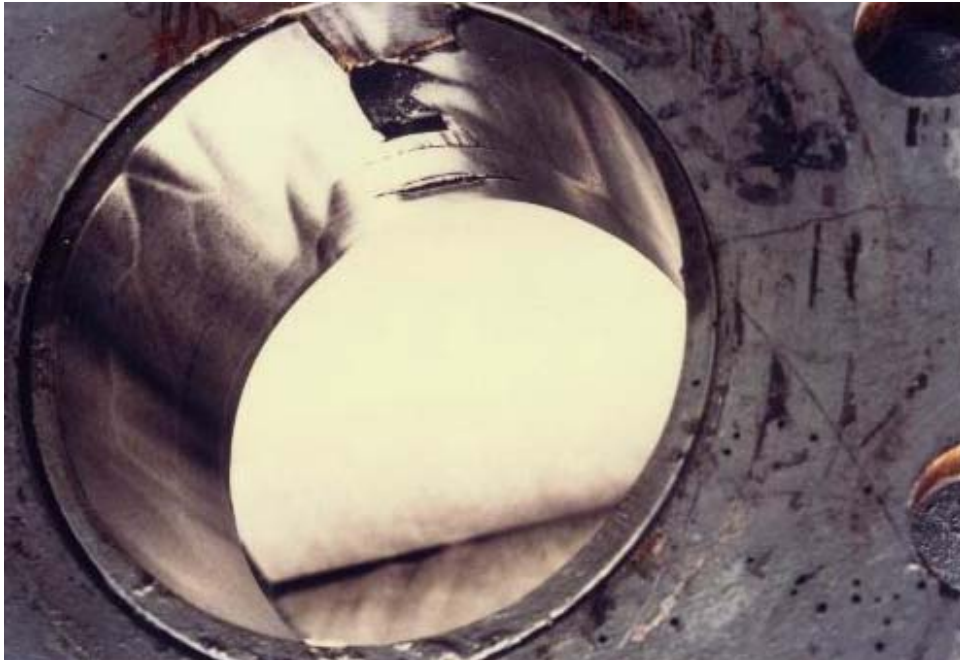
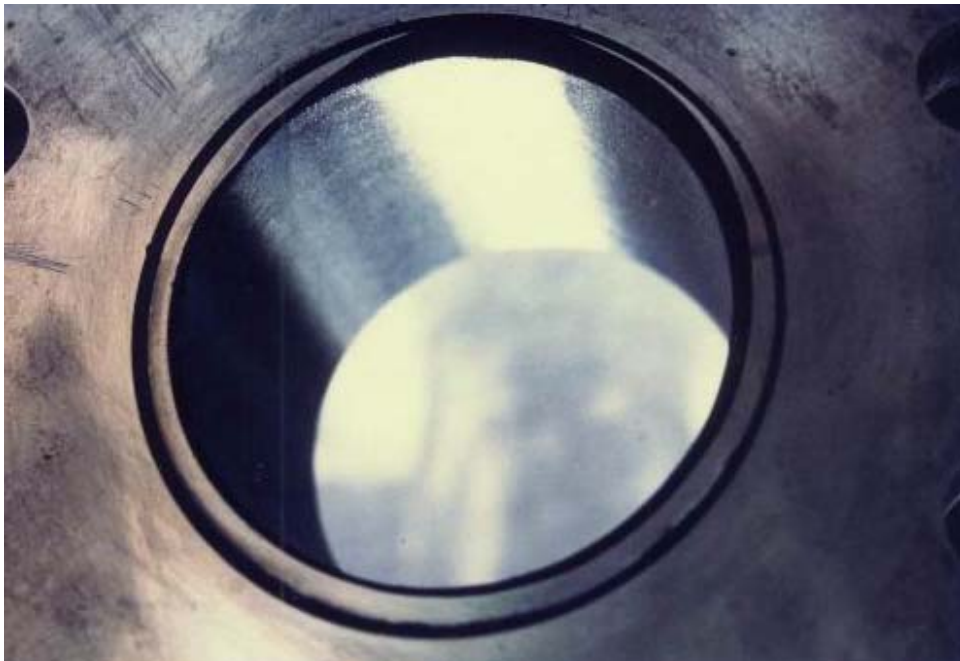
Blocking valves have been reconstructed by using Ceramium. Responsible was serious wear and tear on the steel alloy caused by the clay loam.
