Worldwide repairs carried out with PolymerMetal®

REP-# 001

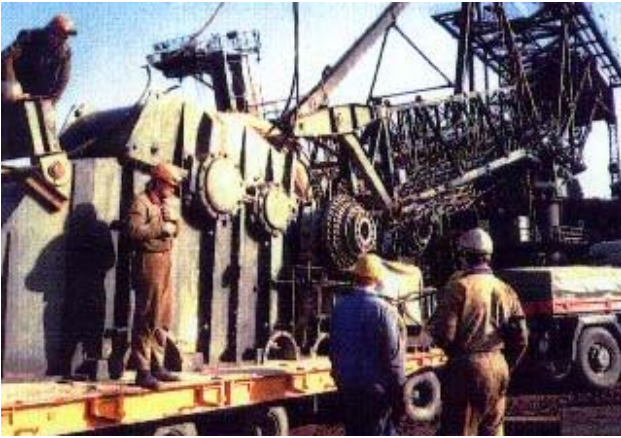
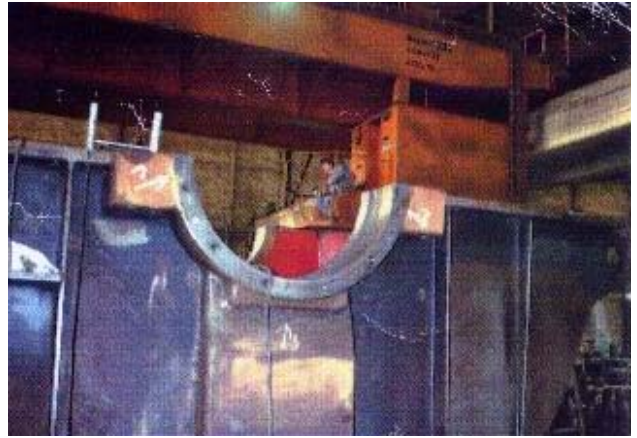
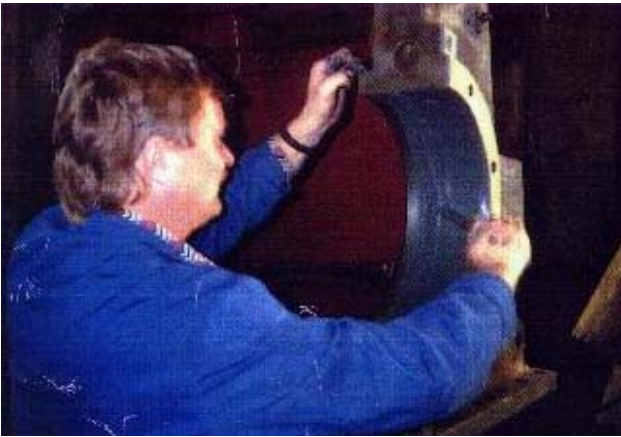
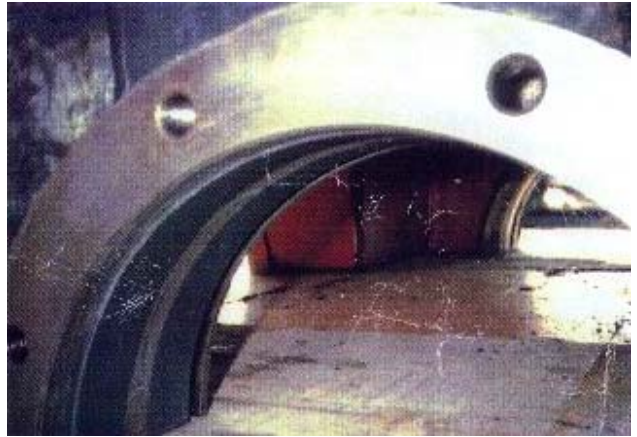
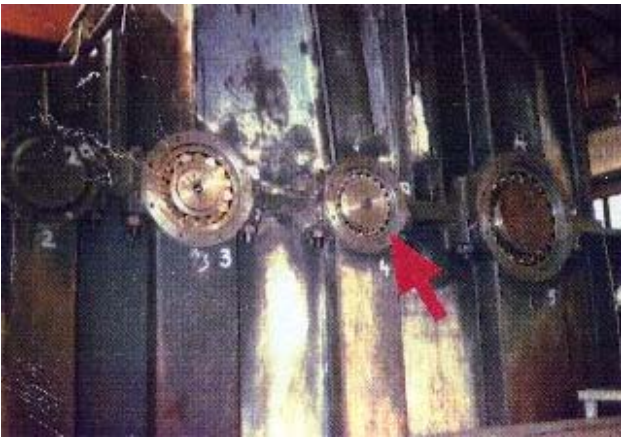
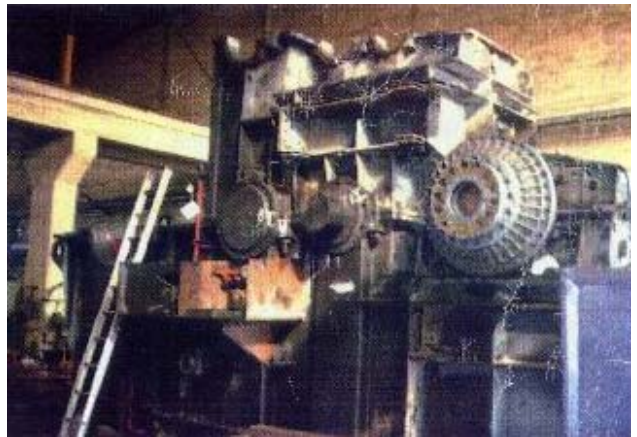
Repair of 14 bearing bushes of the gear box, which is destined to the bucket wheel drive of an excavator for the field of open-cast mining. The worn bearing bushes with a diameter of 280 to 580 mm and a width of 130 to 150 mm were reconstructed with MM-metal SS-steelceramic and Hardener yellow. The standstill time of the excavator was considerable reduced to 72 hours.
