Worldwide repairs carried out with PolymerMetal[®]

REP-# 019

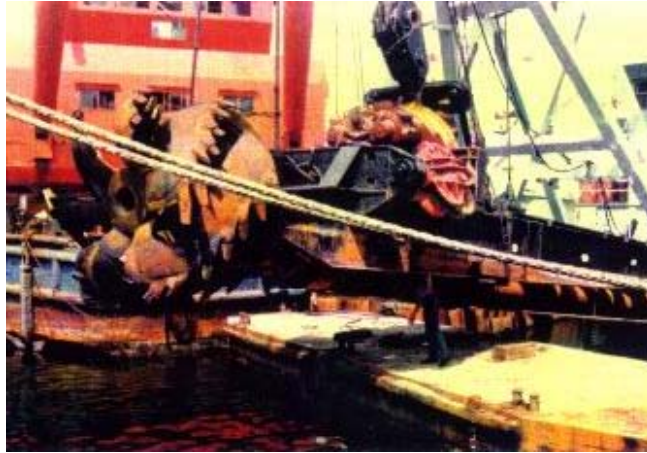
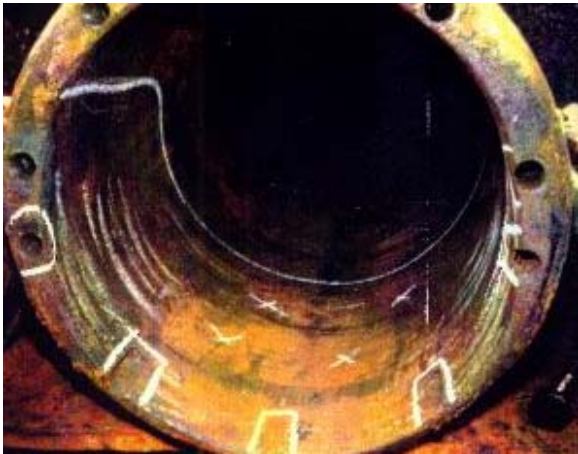
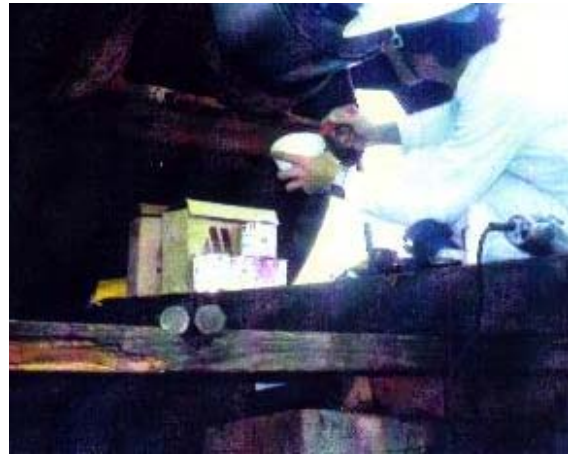
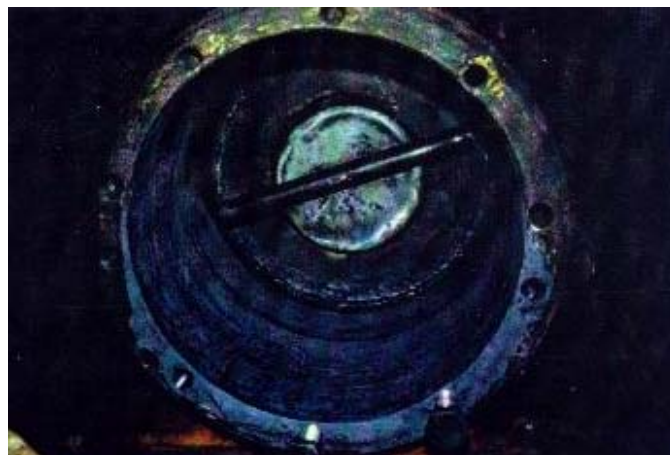
A worn out bearing bush of a floating dredger was rebuilt using MM-metal SS-steelceramic and Hardener yellow. Besides MM-metal SS-steel liquid type with Hardener yellow liquid was injected into a gap of 4 mm between bearing bush and boom.
